ARCHEOLOGICAL EXPLORATIONS IN  
THE CORDILLERA VILCABAMBA  
SOUTHEASTERN PERU

PAUL FEJOS

New York • 1944

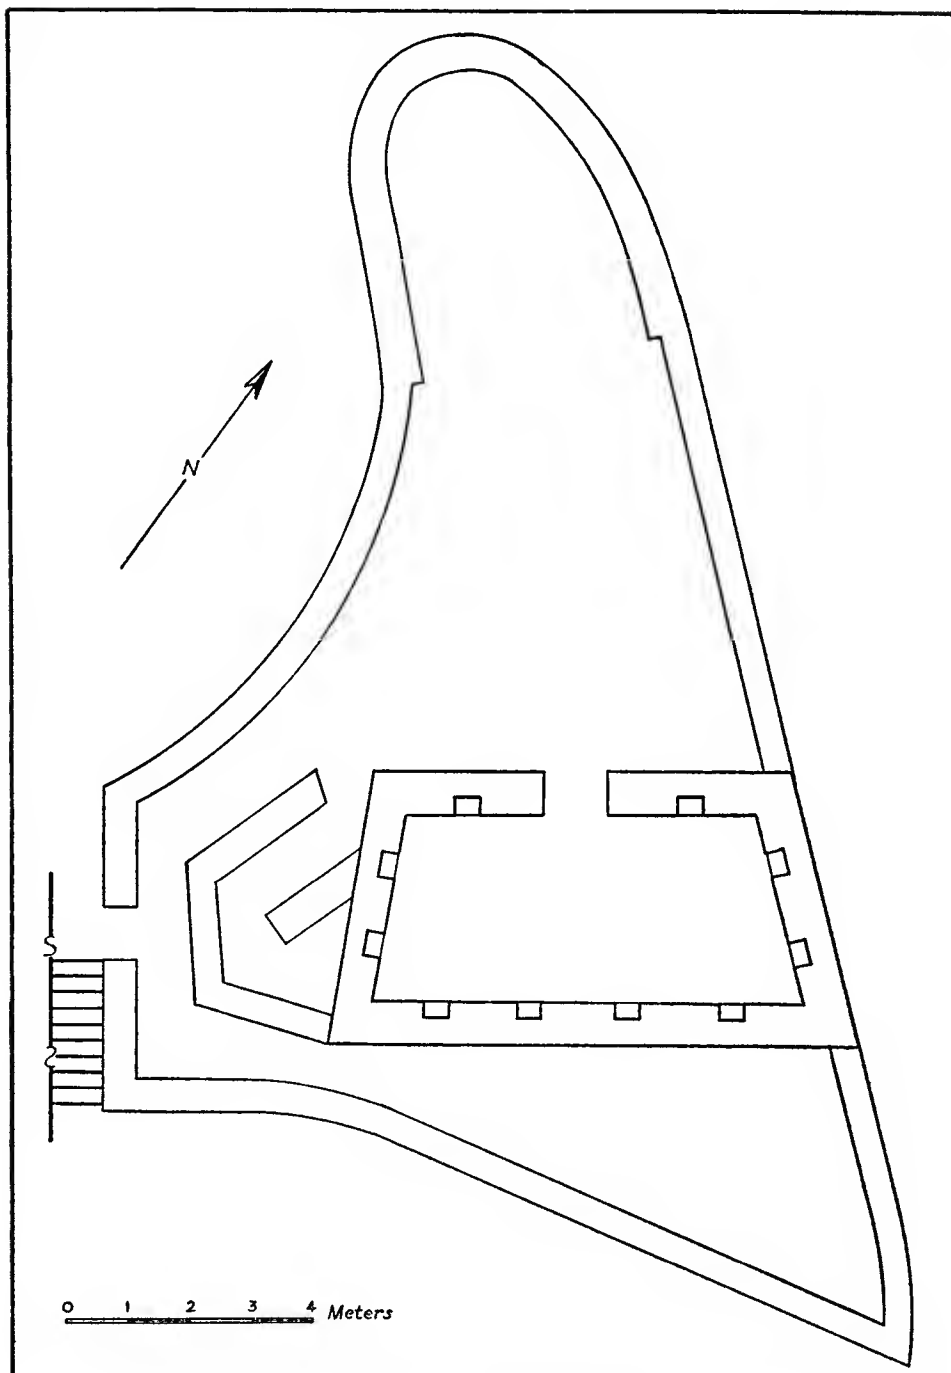
FIG. 4. PLAN OF HOUSE GROUP 1 AT PHUYU PATA MARKA

interior niches (Fig. 4 and Pl. 8, *BOTTOM*) and a row of three cylindrical peg stones along the back wall above the niches (Pl. 5). The outbuildings are of irregular shape but are also well built. The enclosure wall swings out in front of each house to a

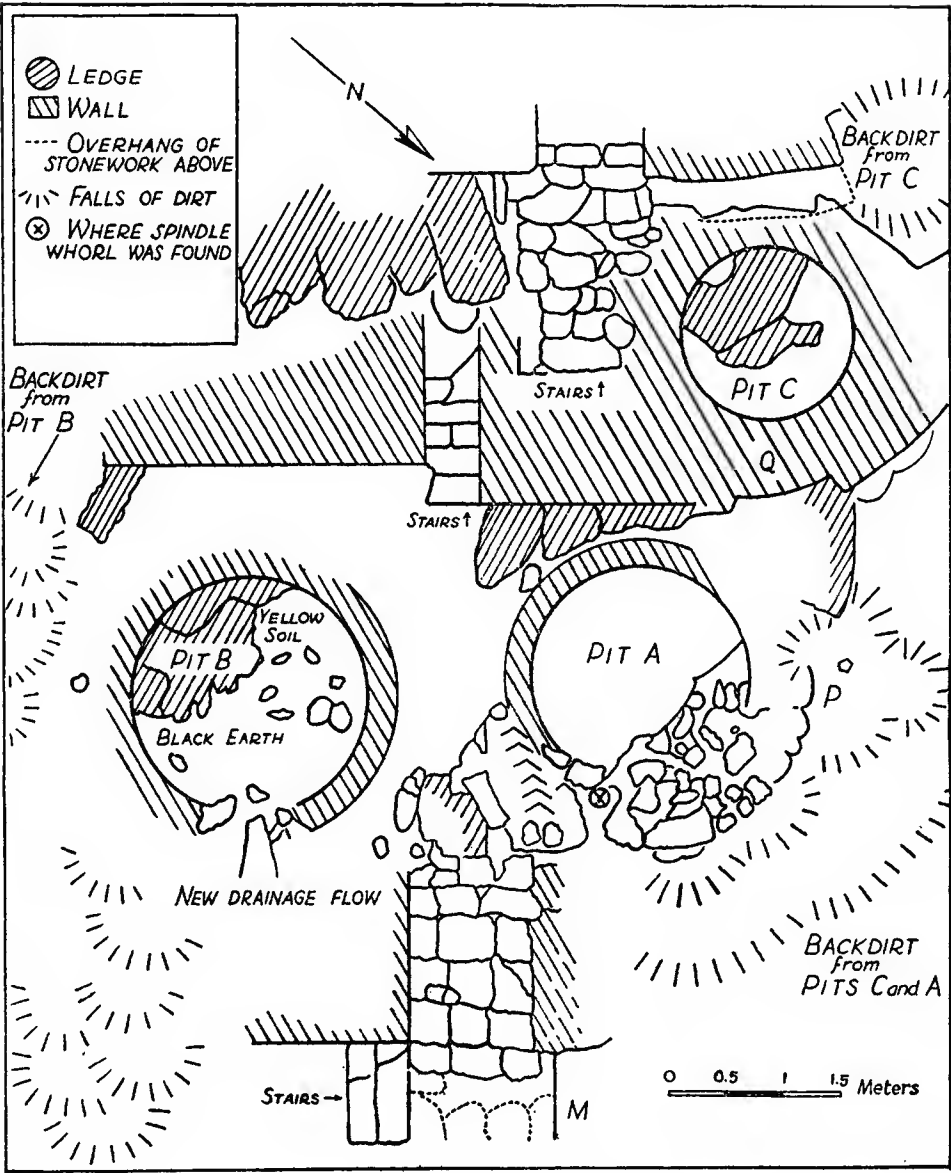
FIG. 17. MAP OF THE EXCAVATIONS BY JOHN H. ROWE AT CHOQUESUYSU

I cleared two areas outside the pits: one on the south side of Pit A, between it and the terrace wall above. Here I hit bedrock under about 20 centimeters of humus. The other was at the head of the lower staircase, north of Pit B. I was trying to find out how the stairs continued up between the pits. If stairs or a paving were ever present, no trace of them is left. I found yellow earth and rough bedrock.

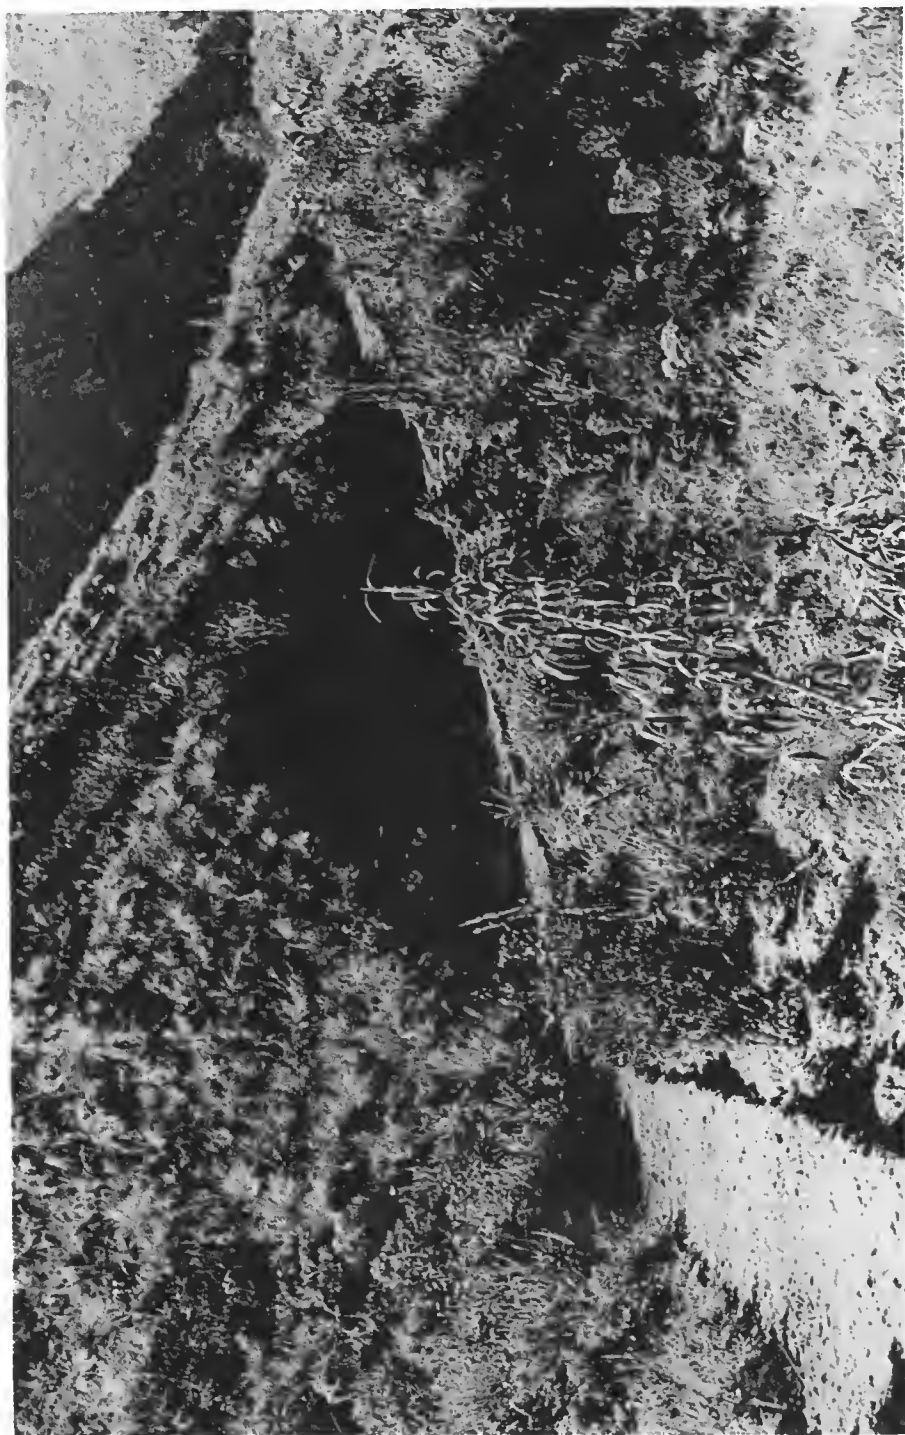
ROAD BETWEEN PHUYU PATA MARKA AND SAYAC MARKA

These roads vary from one to two and one half meters in width and are paved throughout their entire length with flat granite blocks about one third of a meter in diameter. Where irregularities in the bedrock caused it to project above road level, it was cut down to form part of the road surface. In the steeper parts of the roads, the steps are in part constructed of stone blocks and in part cut directly into bedrock. Thus it is not uncommon for one to climb three, four, or more steps cut in solid rock, then steps constructed of stone blocks, and again more steps cut into solid rock. When the original bedrock surface made it suitable for only a portion of the width of the roads or staircases, this portion was utilized and the road was brought to its normal width by stone blocks placed on one or both sides of it.
